# **INDOOR AIR QUALITY ASSESSMENT**

**Greenfield Public Library  
402 Main Street  
Greenfield, Massachusetts**

Prepared by:  
Massachusetts Department of Public Health  
Bureau of Environmental Health Assessment  
February, 2002

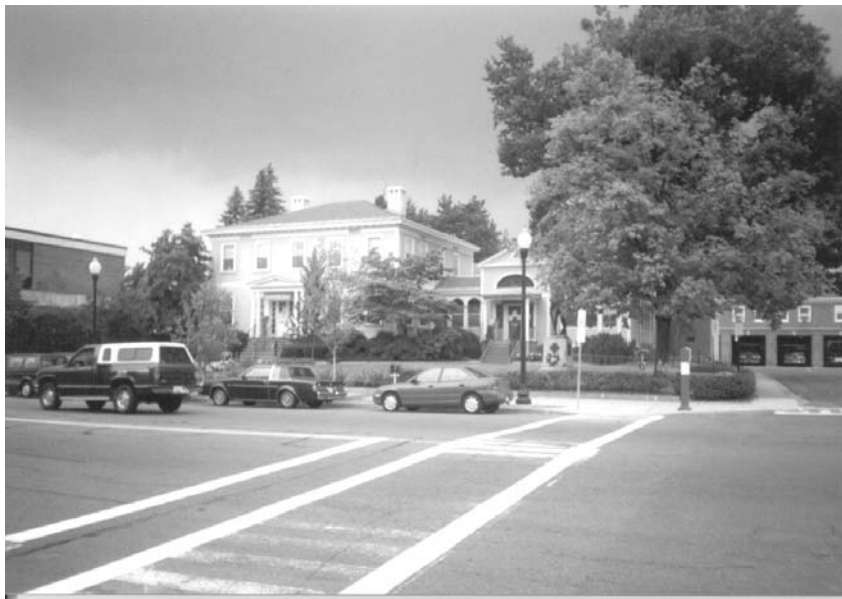
The library contains two wings in a split-level configuration. The original wing was a free standing, two-story, wood frame mansion constructed in 1797 (see Picture 1). A two-story brick wing was added to the rear of the building in the 1950s. The library occupies the first floor of the 1797 wing and the second floor of the 1950s wing. The second floor of the 1797 wing is used for administrative offices. The ground floor of the 1950s wing contains a conference room, an office and restrooms. The basement of the 1797 wing is used for storage of books and contains a mechanical room and the custodial office. An elevator shaft services each floor of the 1797 wing. Windows are sash windows that are not openable. The library exhaust ventilation was renovated in 1998 (MJA & KL, 1998). Exhaust vents were removed and new motors were added to the basement and first floor.
